## **Buena Vista Creek Channel Maintenance Project Biological Resources Technical Report**

**City of Carlsbad**  
1635 Faraday Avenue  
Carlsbad, California 92008  
*Contact: Sherri Howard*

**DUDEK**  
605 Third Street  
Encinitas, California 92024  
*Contact: Megan Enright*

# **FEBRUARY 2013**

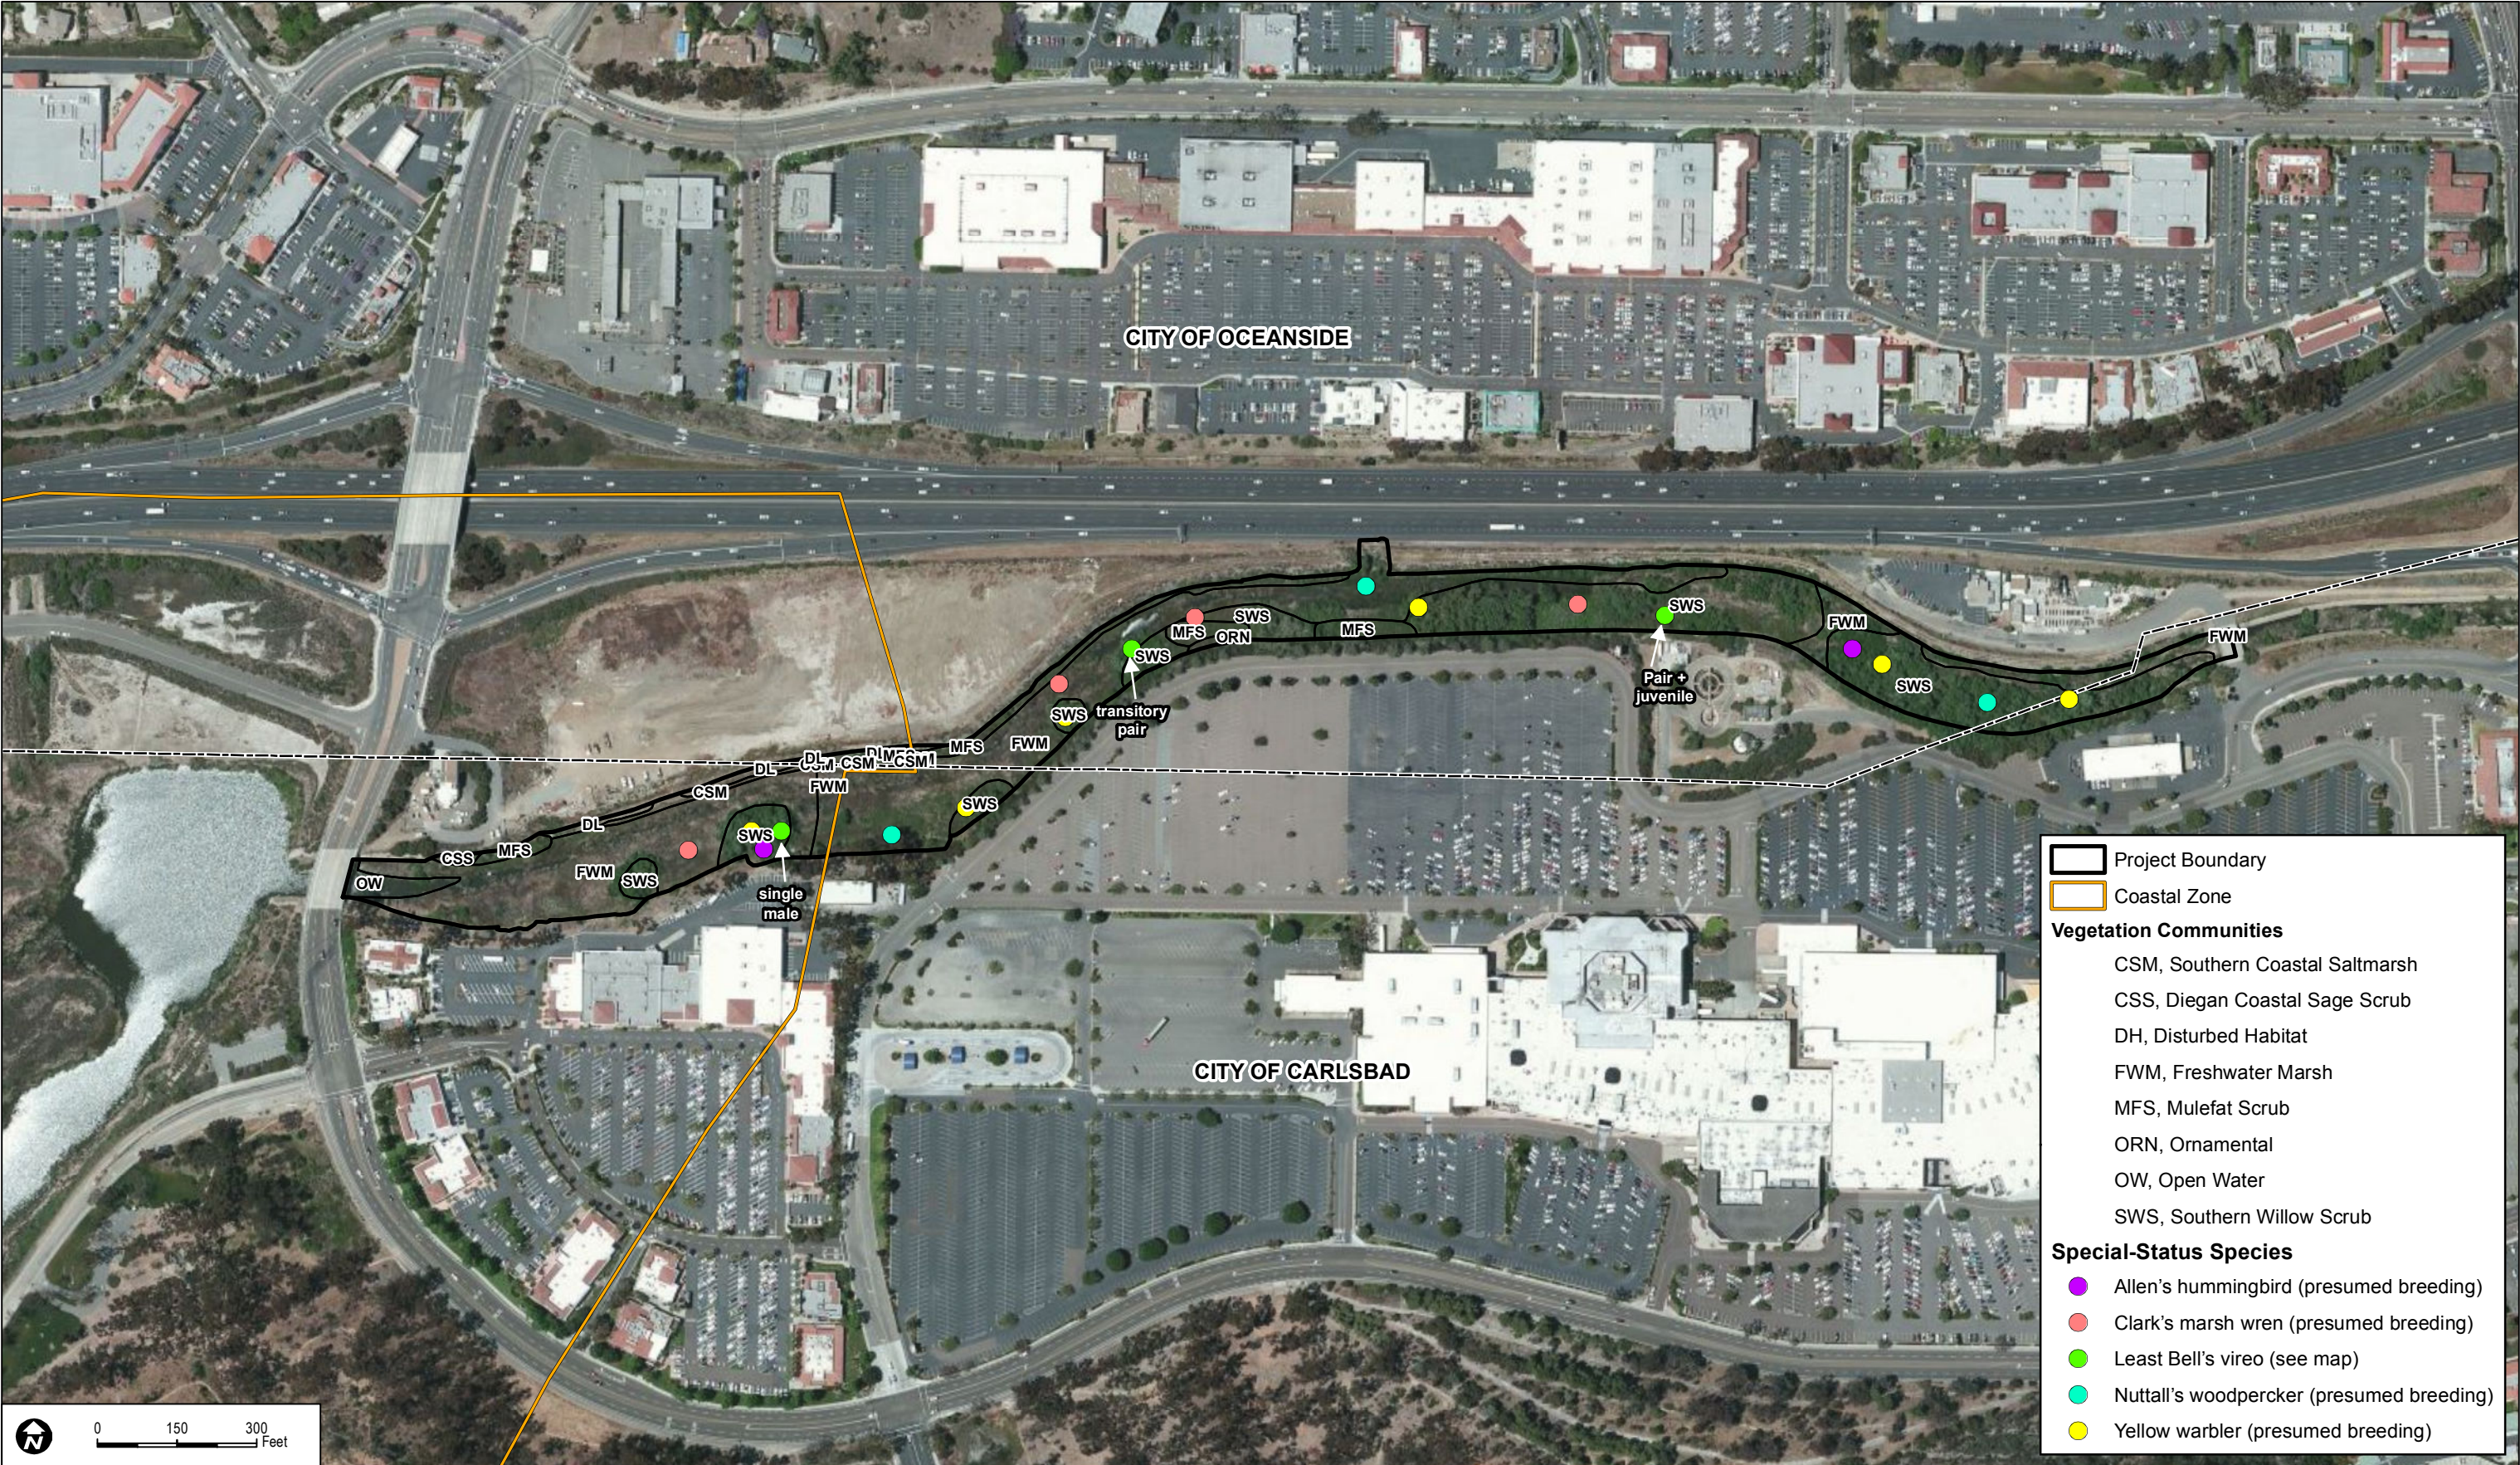
- Project Boundary**  
Project Boundary
- Coastal Zone**  
Coastal Zone
- Vegetation Communities**
- CSM, Southern Coastal Saltmarsh
  - CSS, Diegan Coastal Sage Scrub
  - DH, Disturbed Habitat
  - FWM, Freshwater Marsh
  - MFS, Mulefat Scrub
  - ORN, Ornamental
  - OW, Open Water
  - SWS, Southern Willow Scrub
- Special-Status Species**
- Allen's hummingbird (presumed breeding)
  - Clark's marsh wren (presumed breeding)
  - Least Bell's vireo (see map)
  - Nuttall's woodpercker (presumed breeding)
  - Yellow warbler (presumed breeding)

Focused surveys for least Bell's vireo were conducted in 2012. There are approximately 4.7 acres of suitable habitat for least Bell's vireo in the project area (southern willow scrub and mulefat scrub). Least Bell's vireo was documented during all survey visits. In total during all surveys, one pair and one male were mapped in southern willow scrub-dominated vegetation along the Buena Vista Creek channel on site (Figure 4-1). The pair of vireos was observed in the easternmost portion of the creek channel. The pair was observed foraging with a juvenile. One juvenile was confirmed; however, others could have been present and not detected due to the density of vegetation. The single male was observed during most surveys. He was never observed with a female. He was observed within a willow patch that is both on and off site (Figure 4-1). Another pair was observed during the May 15 survey only.

Yellow warbler is a BCC and SSC species. It is not included in the "covered" species under either the Carlsbad HMP or the Oceanside HCP/NCCP. Six yellow warblers were observed during the least Bell's vireo/southwestern willow flycatcher surveys (Figure 4-1). These birds are likely nesting in the project area.

Clark's marsh wren is an SSC species. It is not included in the "covered" species under either the Carlsbad HMP or the Oceanside HCP/NCCP. Four wrens were observed during the least Bell's vireo/southwestern willow flycatcher surveys (Figure 4-1). These birds are likely nesting in the project area.

Allen's hummingbird and Nuttall's woodpecker are BCC species; they are not included in the "covered" species under either the Carlsbad HMP or the Oceanside HCP/NCCP. Nuttall's woodpecker could nest in cavities of the larger trees. Allen's hummingbirds were observed throughout the surveys and are likely nesting in or near the project area (Figure 4-1).

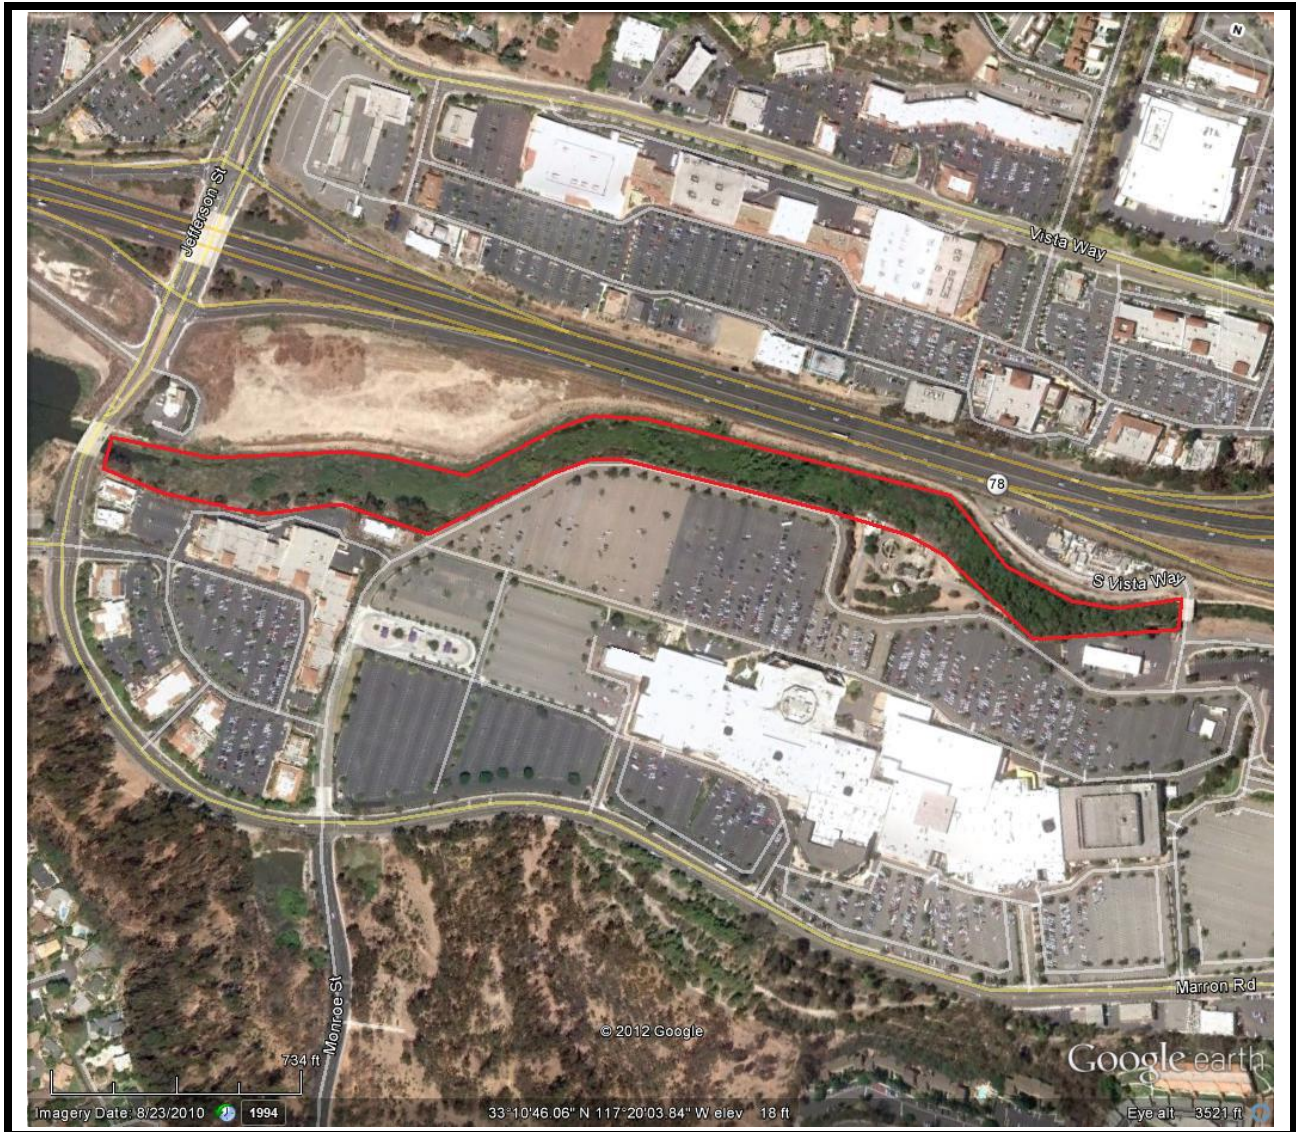
**Figure 1.** Location of the Light-footed Clapper Rail Survey Area (red polygon) for the Buena Vista Creek Channel Maintenance Project, Cities of Carlsbad and Oceanside, San Diego County, California, 2012.
